# DREDGING & DEWATERING

## Kestrel South

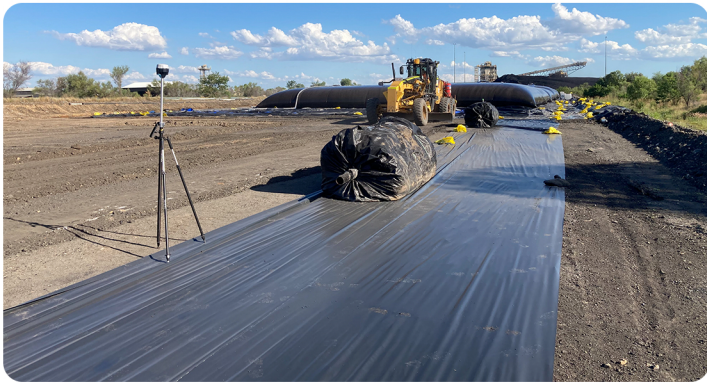
Two silt traps totalling approximately 40,000m<sup>3</sup>, upstream from a holding dam had become full of coal fines running down from the adjacent stockpile. This was beginning to cause silt ingress to the holding dam. Removal was complicated because despite having access ramps, the traps were HDPE lined so could not be cleaned using earthmoving equipment.

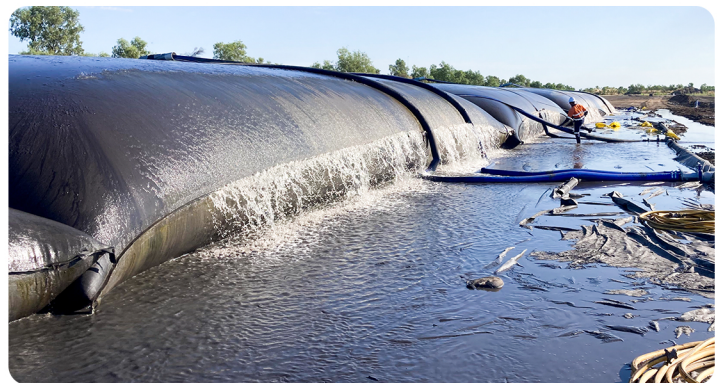
To utilise one of our VMI dredges fitted with Liner-Guard system to allow recovery of the material without damaging the liner. Due to long batters craneage would be difficult, so this was launched and retrieved using our super-tilt trailer and the access ramps. A Geotube farm was constructed in an area adjacent which allowed capture of the coal fines, while returning the water. Recovered material was dried, recovered and blended back into the stockpile. This methodology meant that it was possible to clean the traps and use the recovered material to help finance the works.
